The New Piper Aircraft, Inc.
 2926 Piper Drive
 Vero Beach, Florida, U.S.A. 32960

SERVICE No. 1103B BULLETIN

Date: November 25, 2003 (S)

ENGINE MOUNT INSPECTION

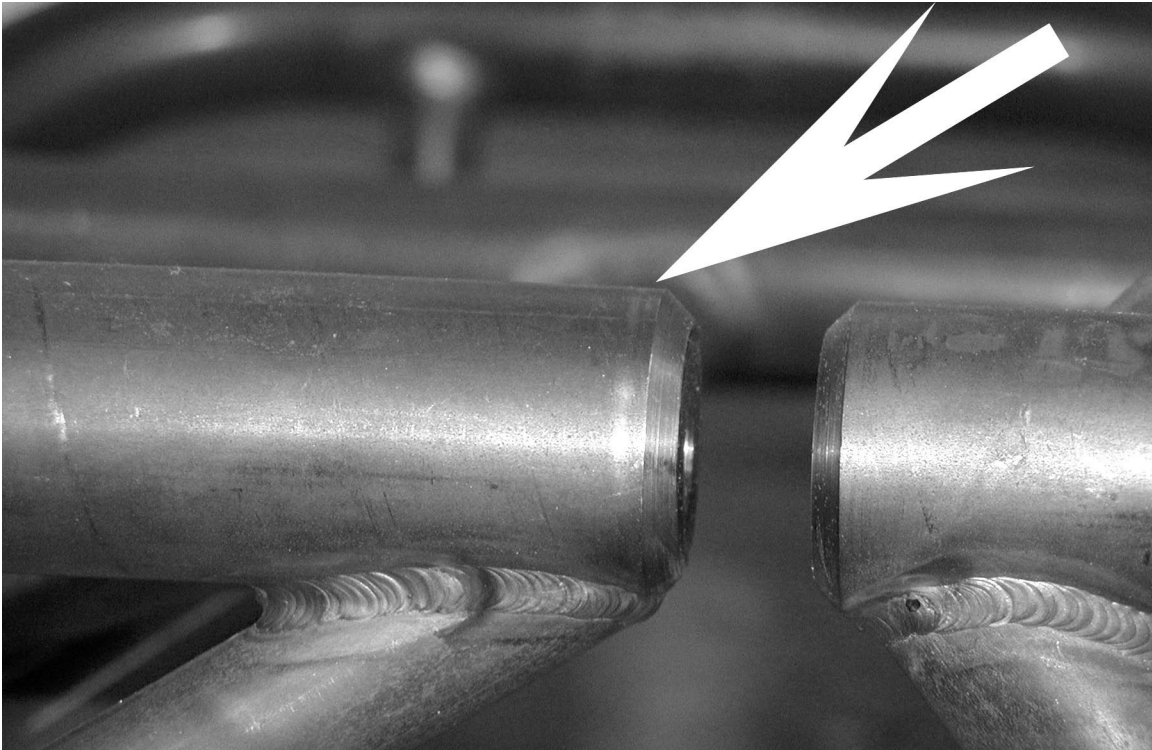
Figure 3
New Engine Mount
No Weld - One (1) Piece Foot

1. If cracks are found on the engine mount, replace with the engine mount listed in Table 1 for the applicable aircraft type. Insure the new engine mount has the one (1) piece feet (see Figure 3). The old engine mount (see Figure 2) has a two (2) piece welded foot. This welded area is where the crack's in the engine mounts have been found. Replace engine mount per the Aircraft Maintenance Manual, Chapter 71-00-00.
